ELECRAFT K1 SER #2261

This is the first K1-4 I have built it comes with a four band [40m, 30m, 20m & 17m or 15m] filter board. I chose the 15m over 17m band. I ordered the Backlight modification along with the K1 Auto Tuner for this K1. During the build I elected to have the larger 150 khz tuning range so that I might utilize the Novice portion of the CW sub band. I did not inventory the parts kit. I did not encounter any missing components, but I still recommend that you conduct an inventory of the kit so you know what your looking for.

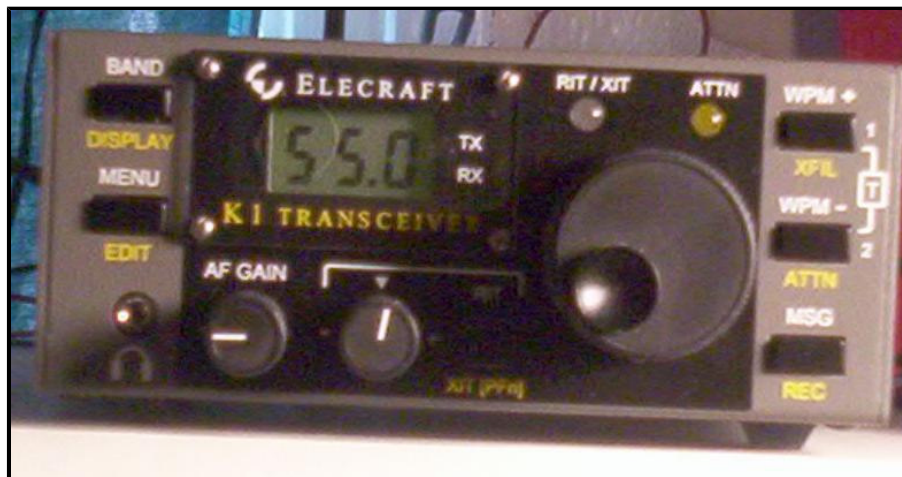
Construction went very smoothly. Until I hit "Alignment and Test, Part II" in the receiver check out. I was receiving VERY HEAVY white noise and no signals. All of the checks and measurements to that point were okay. Using the RF probe that I constructed from the description and circuit supplied in the manual signal tracing was done. Again the measurements were in acceptable limits. DC Voltage checks were conducted according to the supplied documentation in the manual the culprit was located. The 8vdc regulator was putting out 10.89vdc. This excess voltage was overdriving everything. After contacting [Elecraft Parts](#) a new regulator was installed. I am thrilled to report that K1-4 #2261 is perkin' right nicely.
